Ghaggar Flood 2010 as viewed on July 19, 20 and 21, 2010

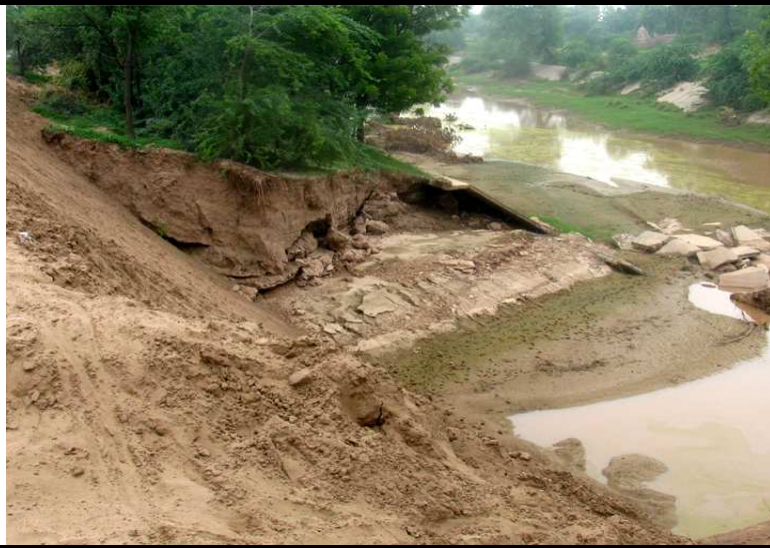
Breach on Sulej-Yamuna Link Canal near Bada Kammi Village in Patiala District of Punjab.

Breach occurred on July 8, 2010

Breach was plugged temporarily.

Water of Pachhisdhara, a tributary of River Ghaggar, entered into Sulej-Yamuna Link Canal through the breach.

SYL canal viewed in the right hand side.

Photograph taken on July 19,2010

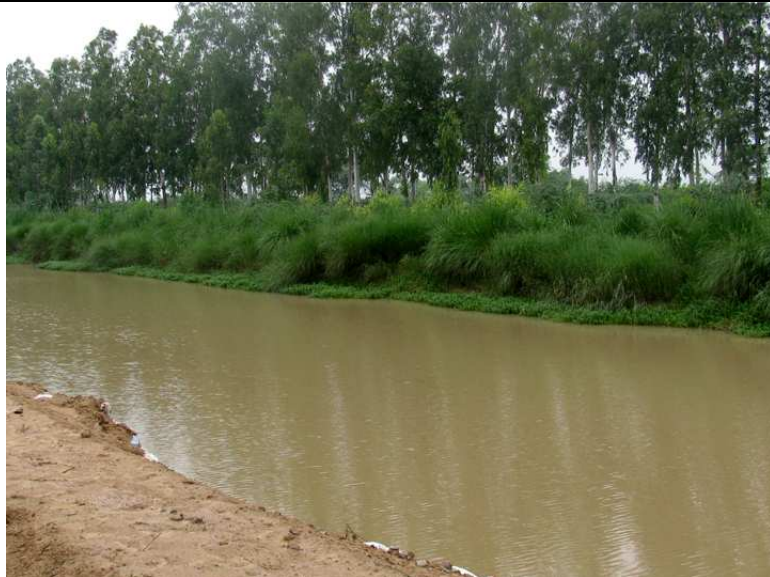
SYL Canal near breach site at Jyotisar, Kurukshetra.

Note level of water (the canal is not suppose to carry any water) and its poor maintenance.

Photographed on July 20, 2010

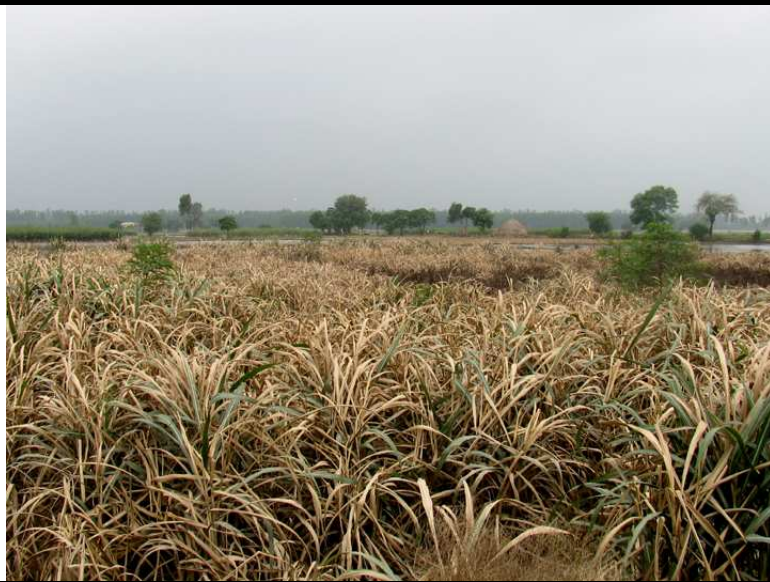
Crop loss due to breach of Sulej-Yamuna Link Canal near Jyotisar, Kurukshetra, Hariyana on July 6, 2010.

Photograph taken on July 20, 2010

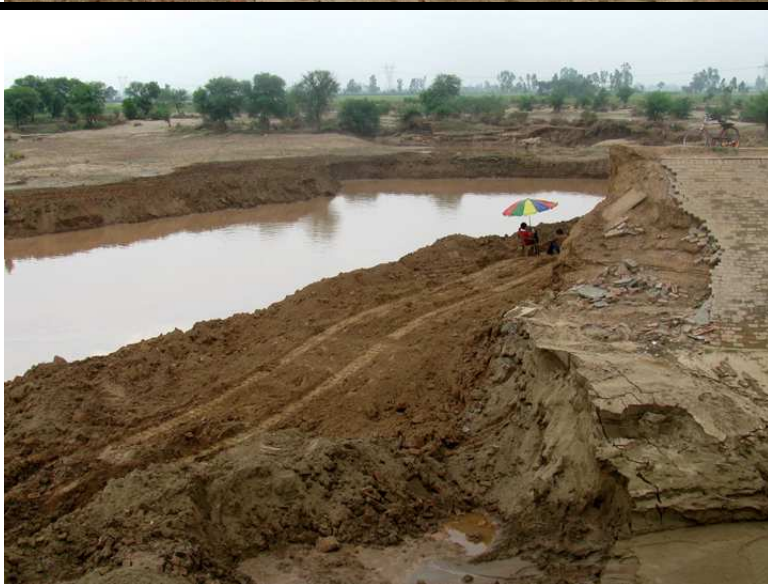
Supervision of repairing work near Tatiana village of Kaithal District in Haryana.
