Uttarakhand Floods of June 2013:

Curtain Raiser on the events at NHPC's 280 MW Dhauliganga HEP

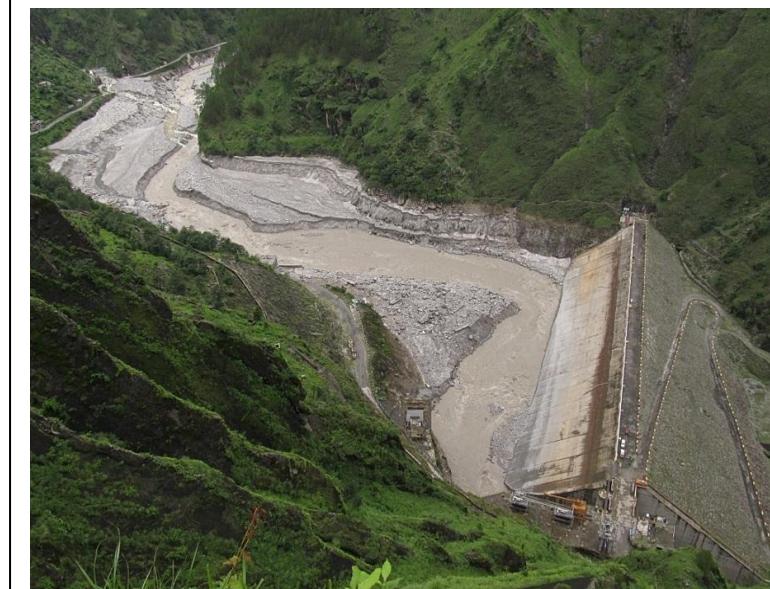
Figure 1 The Dhauliganga Hydro-power dam, after being flushed of bed-load sediment

reservoir was full of debris and sediment before NHPC flushed it. And if you look at the brown line on the concrete face of the dam, you see the level that the reservoir was allowed to fill upto, marked by the 'bath-tub ring' of floating bark and woody debris stuck there after draining.

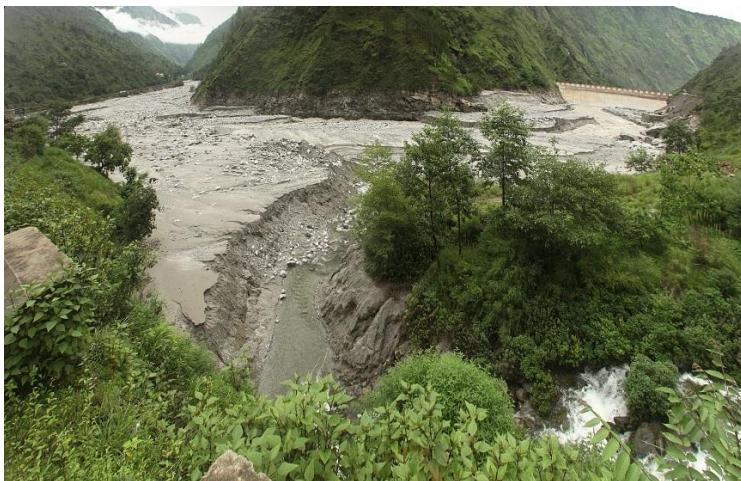
Figure 2 Stitched photo of the bed of the drained Dhauliganga reservoir

According to NHPC, the Peak Flood Design for the Dhauliganga HEP is 3,210 cumecs, at a return interval of 100 years. That is the flow volumes that the dam is designed to be able to take without damage, at flood levels expected at least every hundred years. It is unlikely that flow volumes had reached almost 10 times the flow volumes of the flood on the 15th June at the damsite (389.92 cumecs). NHPC gets its flow data from an automated level-gauge at the reservoir, so it did not require anyone to take readings manually, even prior to abandoning the station. If unprecedented levels had indeed been reached, then why had they held on to water in the reservoir right till the night of the 16th June? Please see the accompanying photographs, of the dam reservoir, empty of water. You can see at least two levels of cut-away terraces. The lower ones are alluvial terraces, consisting clearly of coarser gravels and cobbles deposited by the flowing river. The higher terraces, more visible high on the upper true-left bank in the photo, are remnant lacustrine (lake-bed) terraces, consisting of finer silts and sand, deposited by the stilled waters in the reservoir when it was full. This was the highest point of sediment accumulation in the reservoir prior to being flushed out. Clearly, at least 45% the
