## Uttarakhand Flood Disaster: Role of Human Actions

**Events of June 16-17 at Kedar Nath on the banks of Mandakini River, a tributary of Alaknanda** Based on information from various sources, it seems Kedarnath shrine saw two massive flood events, one starting around 8.15 pm on June 16 and second at 6.55 am on June 17. The flood witnessed at the shrine (located at 3584 m above msl) originated from catchment that includes two mountain peaks: Kedarnath and Kedarnath Dome (6831 m elevation).

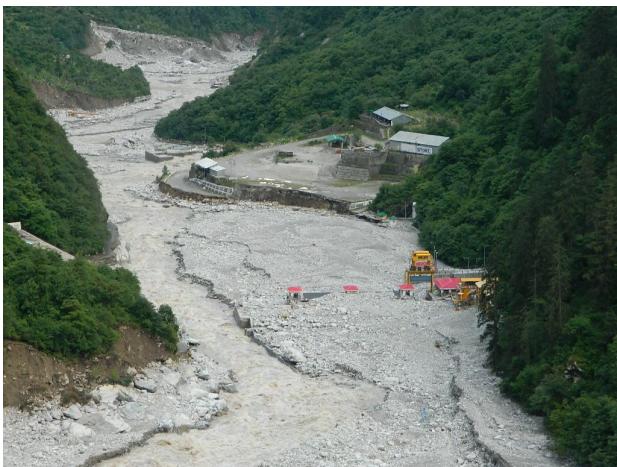
*Vishnuprayag dam filled with boulders, the river bypassed the dam (Photo: Matu Jansangathan)*
