Dams, Rivers & People

Vol 11 | Issue 5-6 | June-July 2013

Uttarakhand Flood Disaster: Role of Human Actions

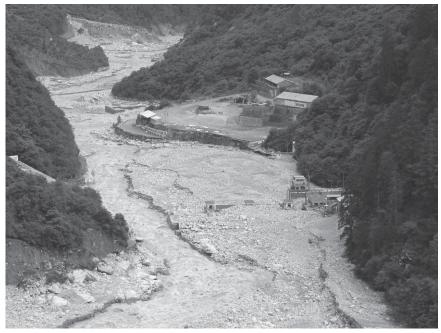
Vishnugad Dam filled with boulders, the river by passed the dam (Photo: Matu Jansangathan)
